# **RESULTS OF ENVIRONMENTAL FINDINGS FOR THE CABIN IN THE SKY**

## **Comstock Mining Inc. Soils Assessment Areas Affected by the Carson River Mercury Site Gold Hill, NV**

*August 13, 2012*

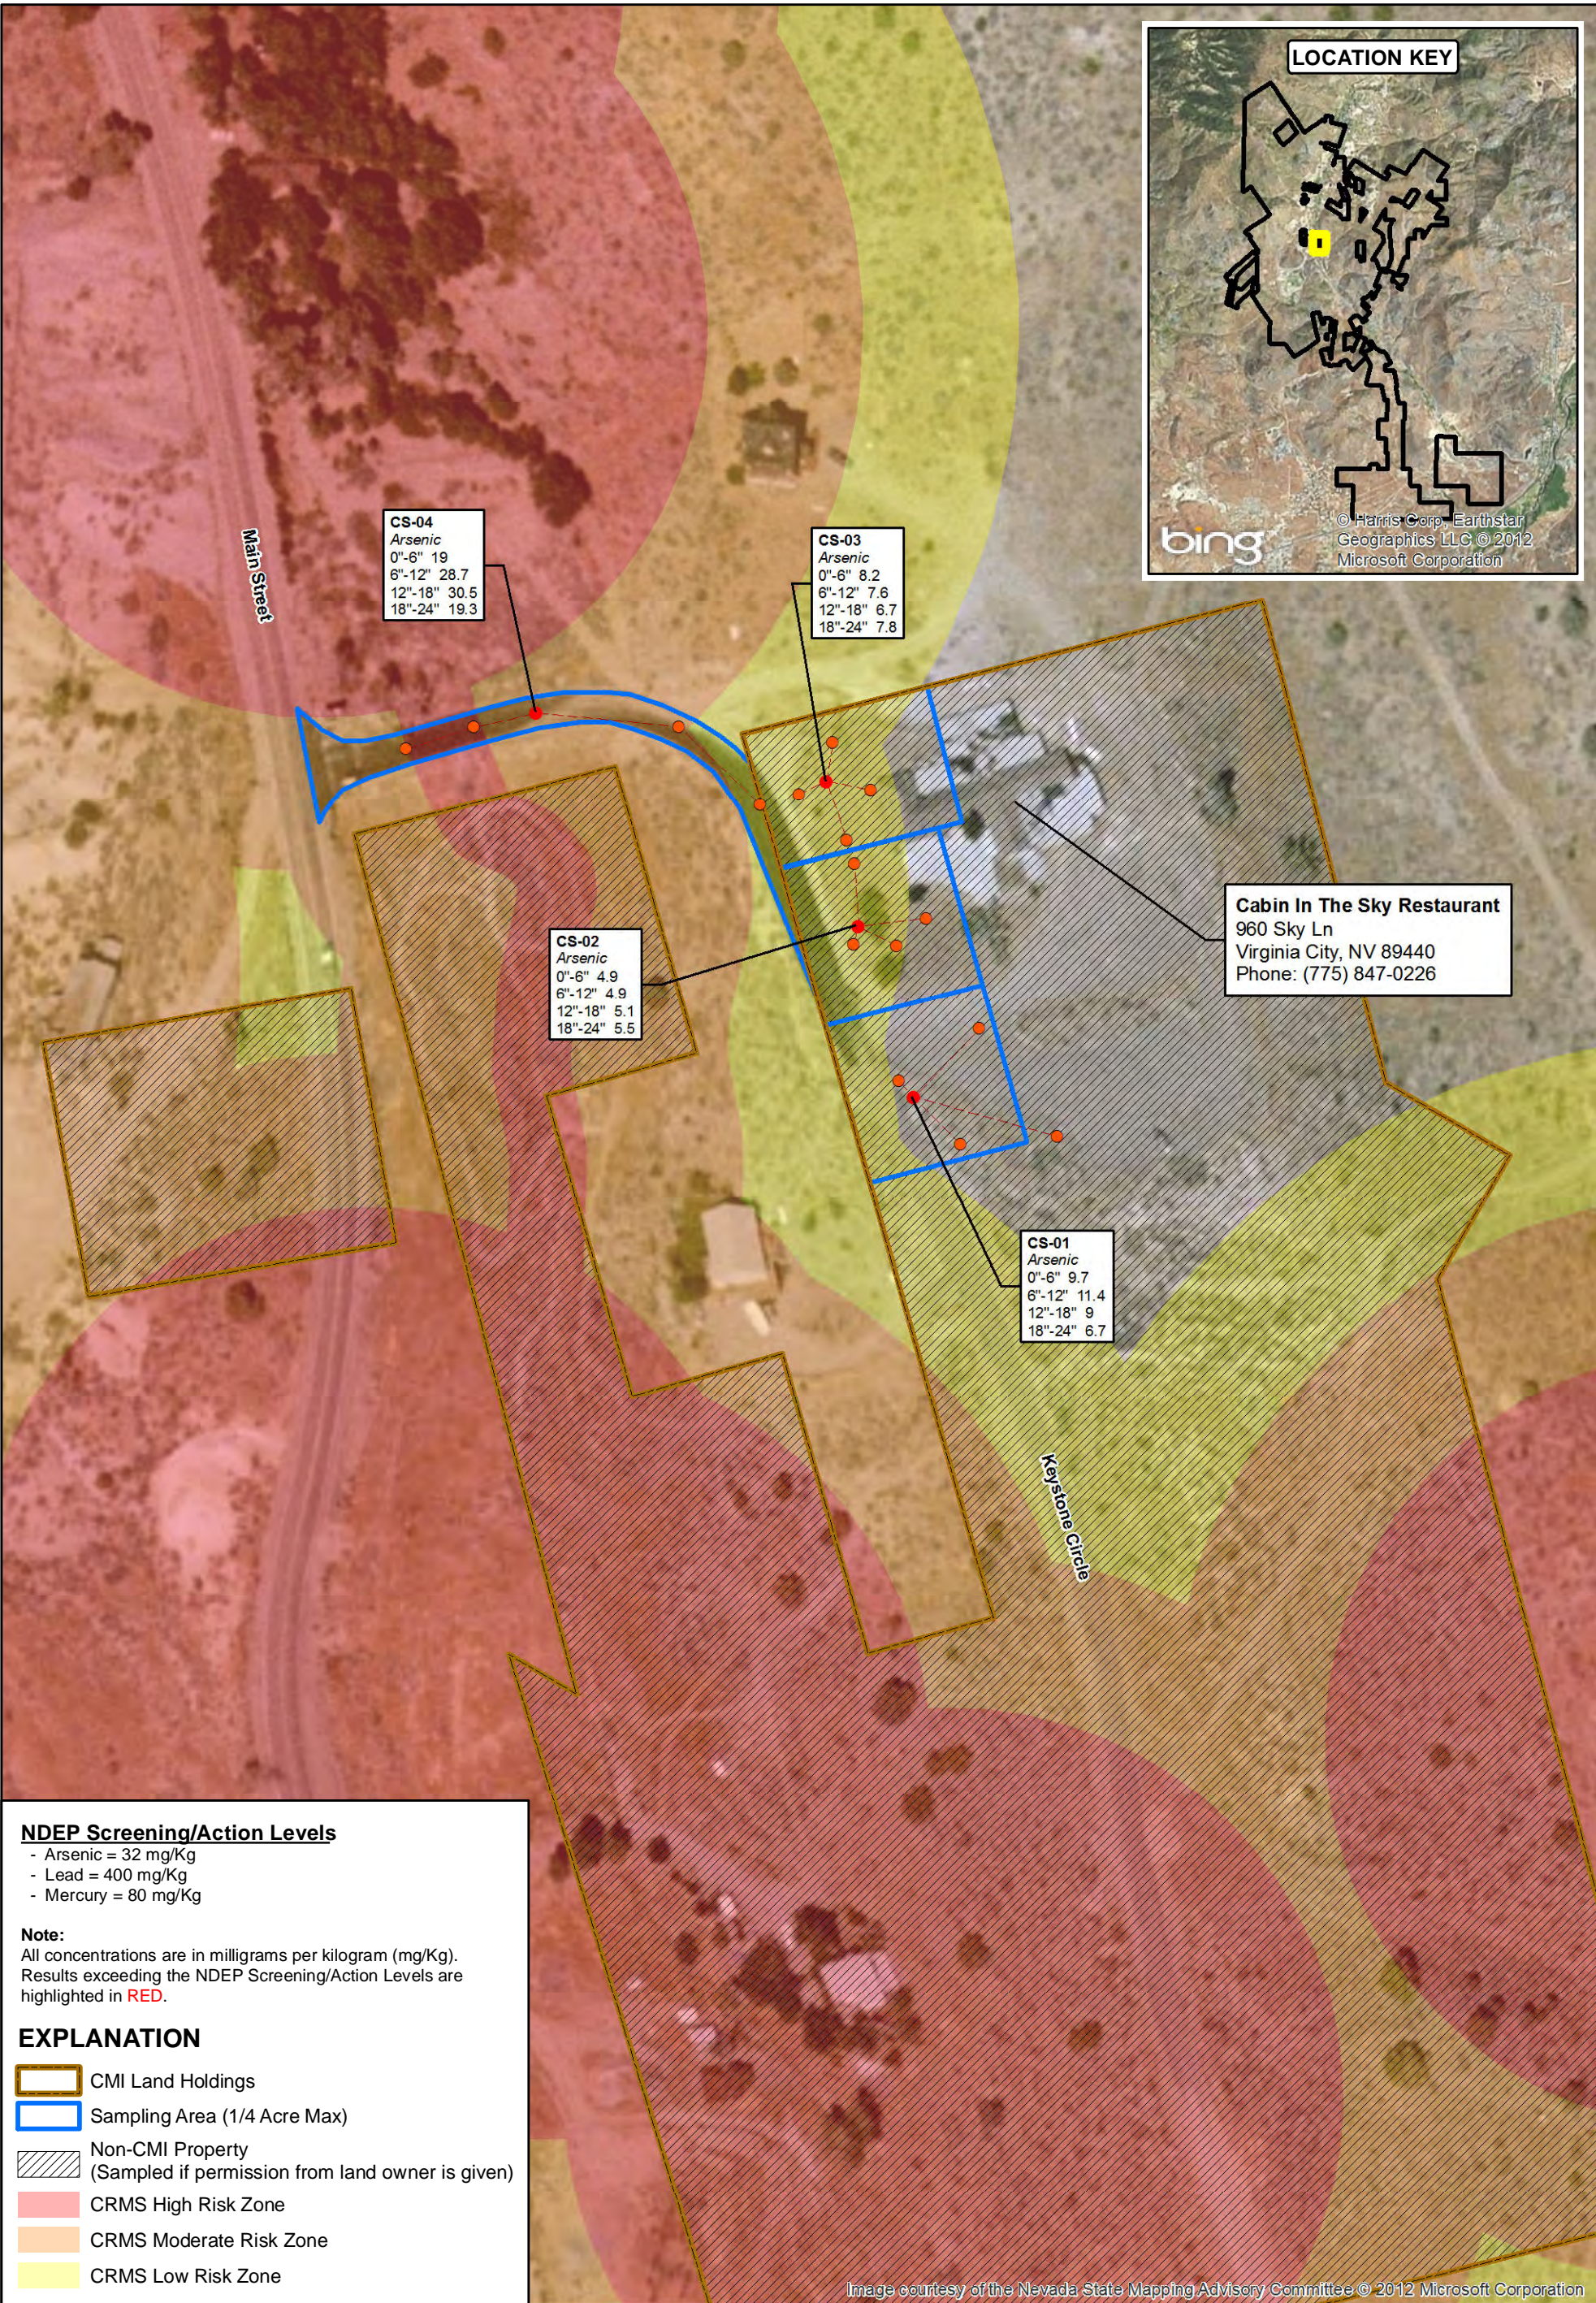
Arsenic data is presented on Table 1 and Figure 2. There were no exceedances of the NDEP's Residential Screening/Action Level. The range of concentrations is from 4.9 to 30.5 mg/Kg. The mean concentration is 11.56 mg/Kg. These data show that the arsenic concentrations within the Cabin in the Sky property are below the NDEP's Residential Screening/Action Level of 32 mg/Kg.

NDEP derived site-specific background values and provided a range of 0 - 90 mg/Kg for arsenic. There are no locations at the site which exceed 90 mg/Kg.

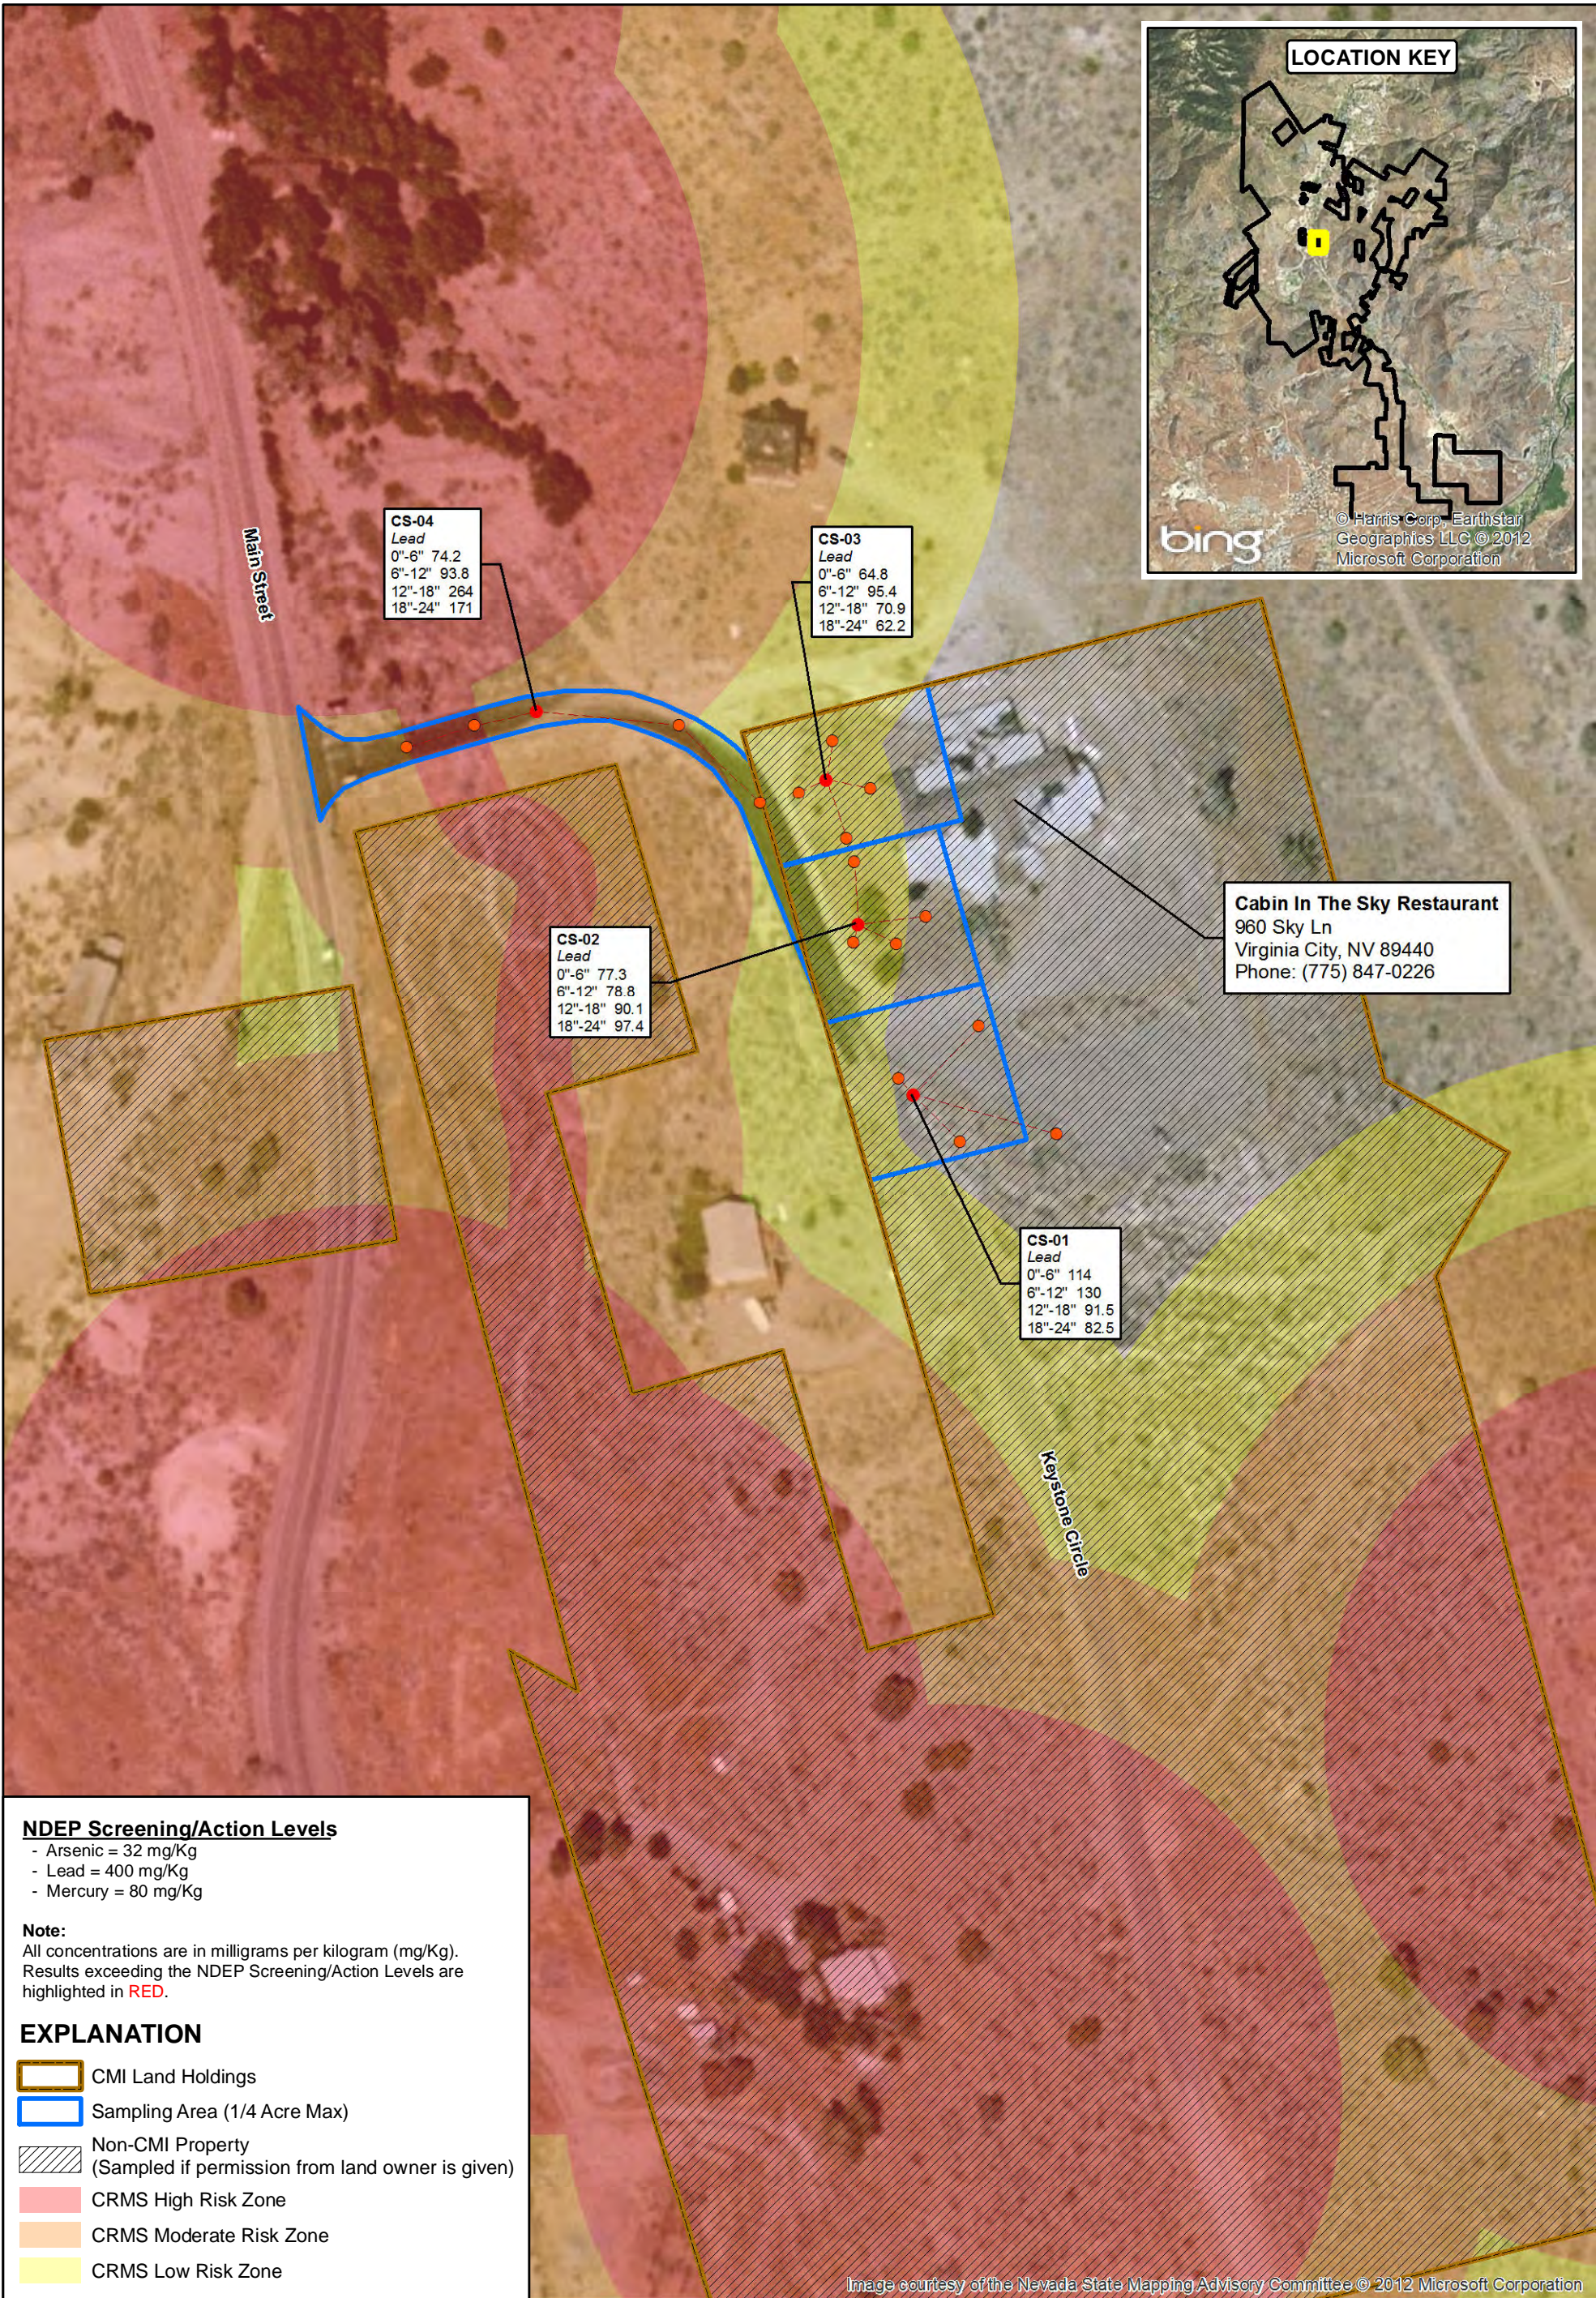
Lead data is presented on Table 1 and Figure 3. There were no exceedances of the NDEP's Residential Screening/Action Level. The range of concentrations is from 62.2 to 264 mg/Kg. The mean concentration is 103.62 mg/Kg. These data show that the lead concentrations within the Cabin in the Sky property are well below the NDEP's Residential Screening/Action Level of 400 mg/Kg.

NDEP derived site-specific background values and provided a range of 0 - 63 mg/Kg for lead. There are several locations at the site which exceed 63 mg/Kg, however, all locations are below NDEP's Screening/Action Levels and/or site-specific background values as derived by the NDEP. These are all classified as Category 3 materials as defined in the NDEP's May 4, 2012 letter and hence are not regulated under CERCLA.

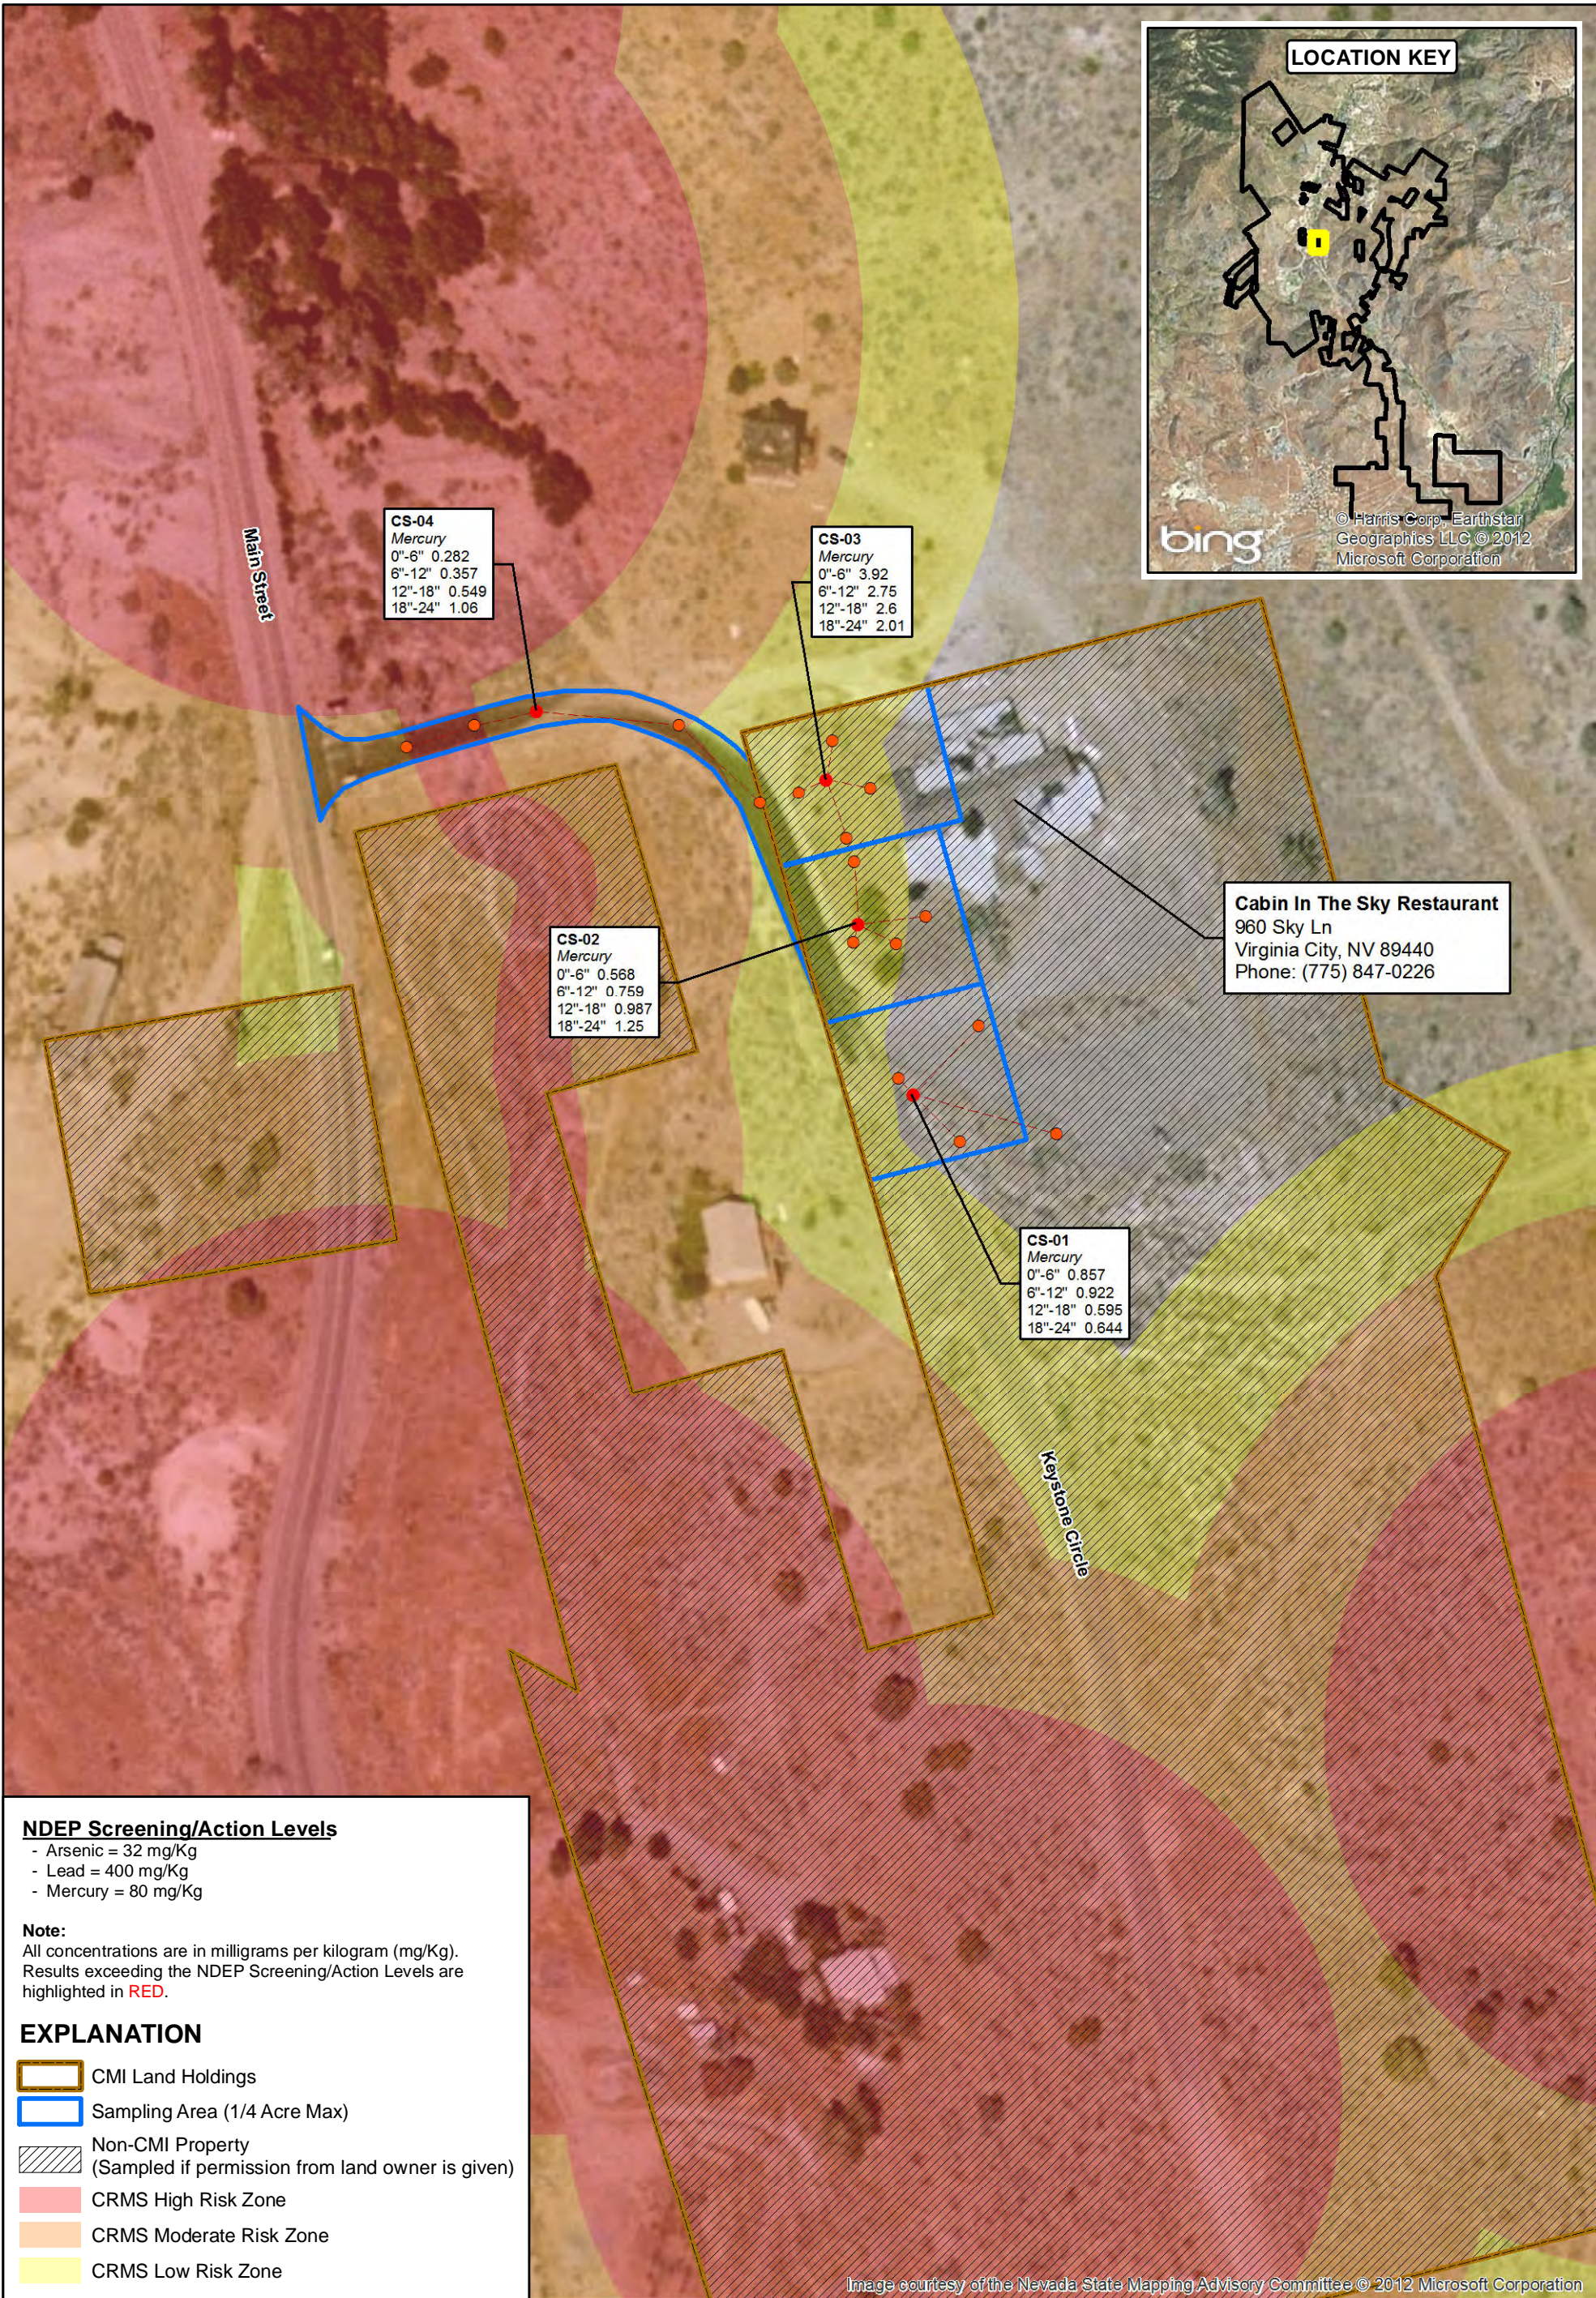
Mercury data is presented on Table 1 and Figure 4. There were no exceedances of the NDEP's Residential Screening/Action Level. The range of concentrations is from 0.282 to 3.92 mg/Kg. The mean concentration is 1.26 mg/Kg. These data show that the mercury concentrations within the Cabin in the Sky property are well below the NDEP's Residential Screening/Action Level of 80 mg/Kg.

NDEP derived site-specific background values and provided a range of 0 - 1.5 mg/Kg for mercury. There are several locations at the site which exceed 1.5 mg/Kg, however, all locations

are below NDEP's Screening/Action Levels and/or site-specific background values as derived by the NDEP. These are all classified as Category 3 materials as defined in the NDEP's May 4, 2012 letter and hence are not regulated under CERCLA.
